GT-2002-30630

**EVALUATING ENVIRONMENTAL BARRIER COATINGS ON CERAMIC MATRIX COMPOSITES
AFTER ENGINE AND LABORATORY EXPOSURES**

ABSTRACT

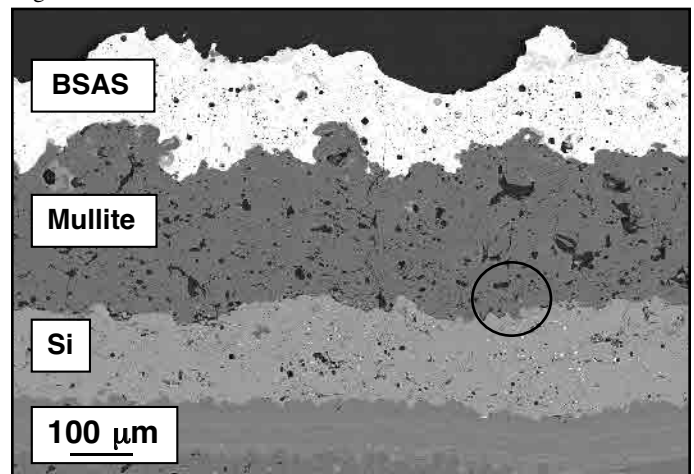
Fig. 1. Typical as-processed microstructure of three layer EBC having a mullite intermediate layer.

With this in mind, differences in the protective capability of each of the two EBCs became apparent in the early stages of exposure in the Keiser Rig. After 1500h at $1200^\circ C$ and 1.5atm H_2O , imaging the Si/mullite (area circled in Fig. 1) or the Si/(mullite+BSAS) (area circled in Fig. 2) interfaces of the EBC revealed oxidation of the Si bond coat which resulted in the formation of SiO_2 at the interfaces during exposure. Differences between the amount of SiO_2 formed after 1500h for the two EBC formulations are shown in Fig. 4 and Fig. 5 for the Si/mullite/BSAS and Si/(mullite+BSAS)/BSAS mixed-layer EBCs, respectively. Note that the amount of SiO_2 formed in the Si/Mullite/BSAS EBC (Fig. 4) was $\sim 5X$ thicker than that formed in the mixed-layer EBC (Fig. 5) indicating that the protective capability of the mixed-layer EBC was superior. In fact, exposure of the Si/mullite/BSAS EBC/CFCC coupon in the Keiser Rig was suspended after 3000h because excessive oxide formation at the Si/mullite interface led to some EBC spallation at this interface. The primary reason for the greater degree of oxidation for the Si/mullite/BSAS EBC is attributed to excessive micro-cracking and porosity within the mullite intermediate layer after EBC processing. The (mullite+BSAS) intermediate layer in the mixed-layer EBC did not show excessive micro-cracking in the as-processed condition. Exposure of the mixed-layer EBC/CFCC coupon was continued for a total exposure time of 6500h. The Si/(mullite+BSAS) interface in the mixed-layer EBC/CFCC after 5000h at $1200^\circ C$ and 1.5atm H_2O is shown in Fig. 6. A comparison of Fig. 5 and Fig. 6 shows only slow thickening of the SiO_2 at extended times, further demonstrating the superiority of this EBC compared to the Si/mullite/BSAS EBC.

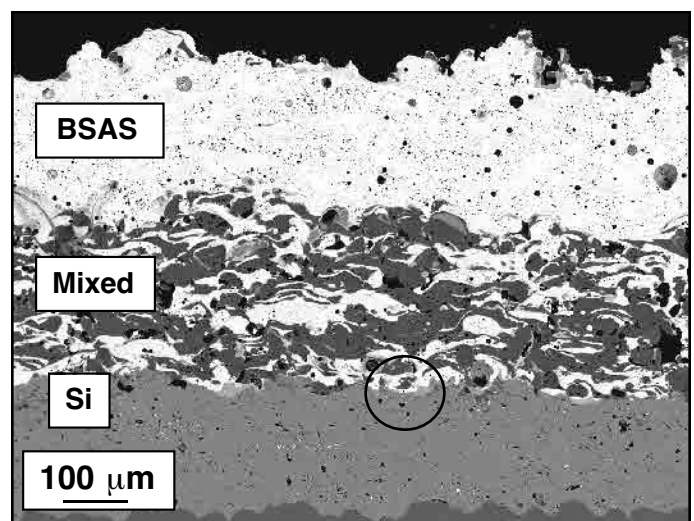
Fig. 2. Typical as-processed microstructure of three layer EBC with "mixed" (mullite+BSAS) intermediate layer.

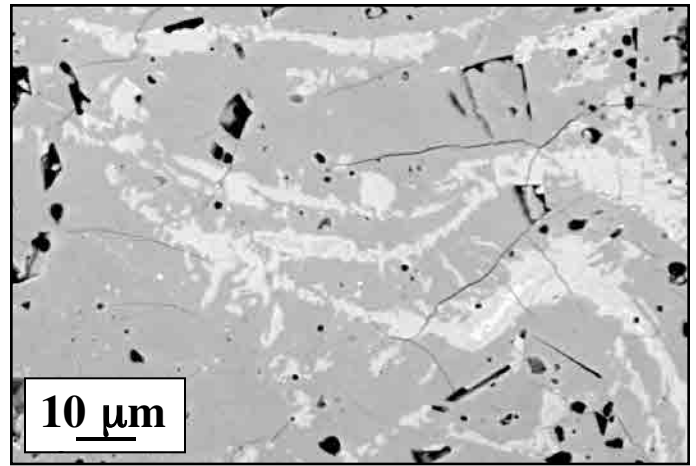
Fig. 11. SEM image of the as-processed BSAS top coat showing a two-phase structure consisting of BSAS (matrix) and a discontinuous Sr-enriched phase (brightly imaging).
